# The MarkIII microphone array: the modified version realized at ITC-irst

Claudio Bertotti<sup>1</sup>, Luca Brayda<sup>2</sup>, Luca Cristoforetti<sup>3</sup>,  
Maurizio Omologo<sup>3</sup>, Piergiorgio Svaizer<sup>3</sup>

<sup>3</sup>ITC-irst, Povo, Trento, Italy

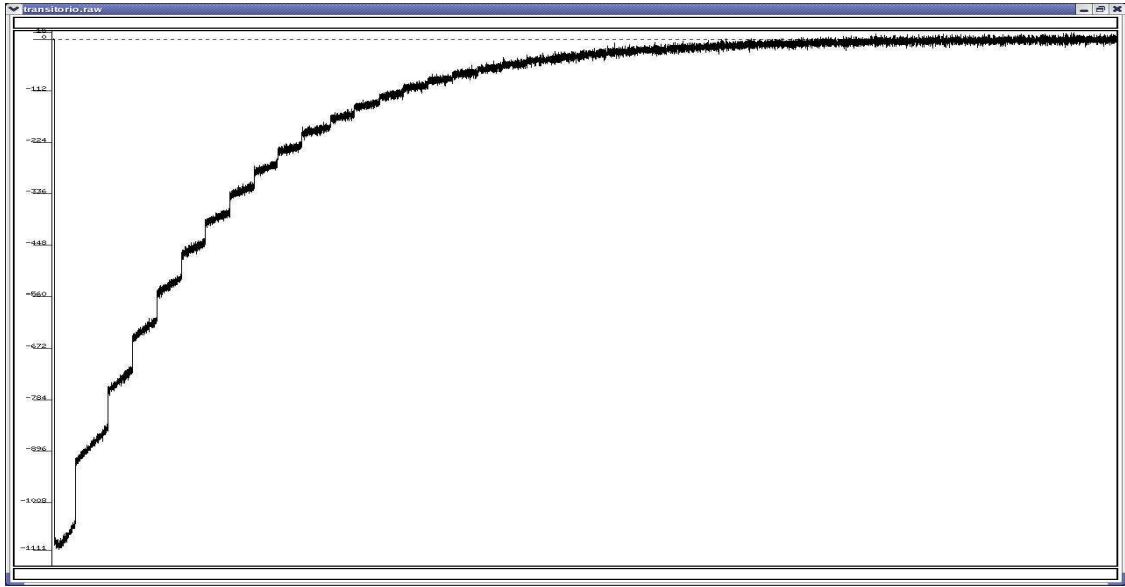
Figure 1: Waveform containing one second of signal coming purely from the devices: the microphone was in fact isolated. A transitory is well visible, due to capacitors charge, as well as the device noise. This suggests to throw out the first 4350 samples at 44100 Hz, i.e. the first 100 ms of each recording.

Moreover, the first samples are characterized by an increase of the signal from a negative level, which should correspond to a charging process in a capacitor (see Figure 1).

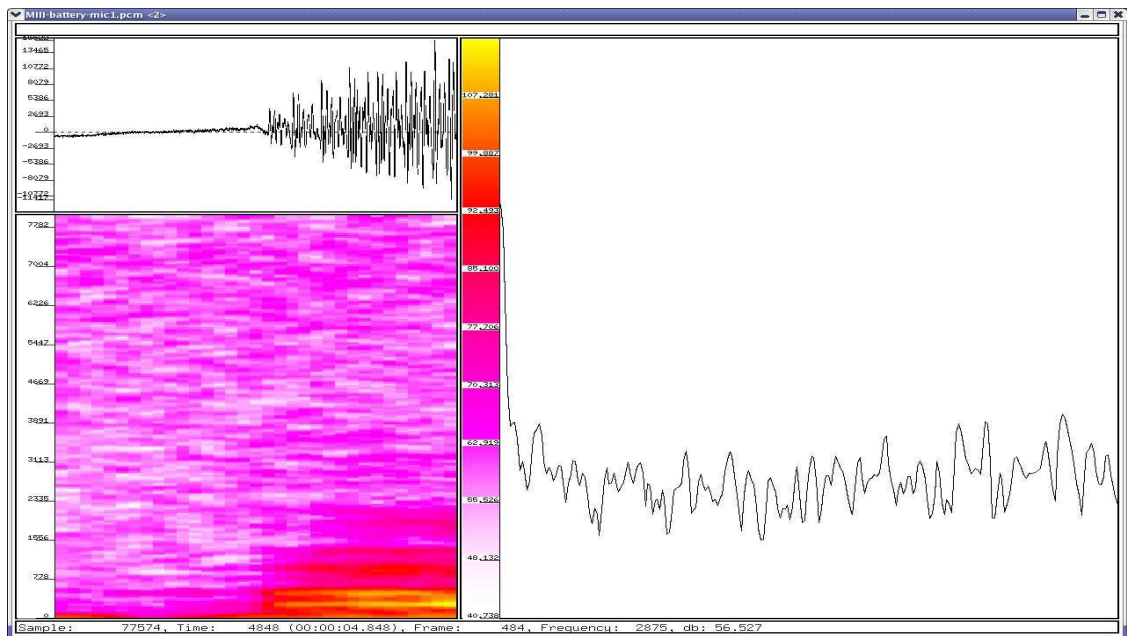
Figure 4: Signal corresponding to a silence followed by a vowel. The lower part of the figure reports the spectrogram. The log power spectrum of the silence segment is given in the right part. This picture was obtained using Sgram software (developed at ITC-irst).

The Figure 4 shows some silence, followed by the beginning of the utterance “A”. As mentioned above, the 50Hz disturbance is not present anymore, the MarkIII being powered by a battery. The spectrum visible on the right part of the same figure refers to that silence period. To better understand the entity of the noise, Figure 5 is related to a zooming (that is a short segment extracted from the first part of the signal of the previous figure).

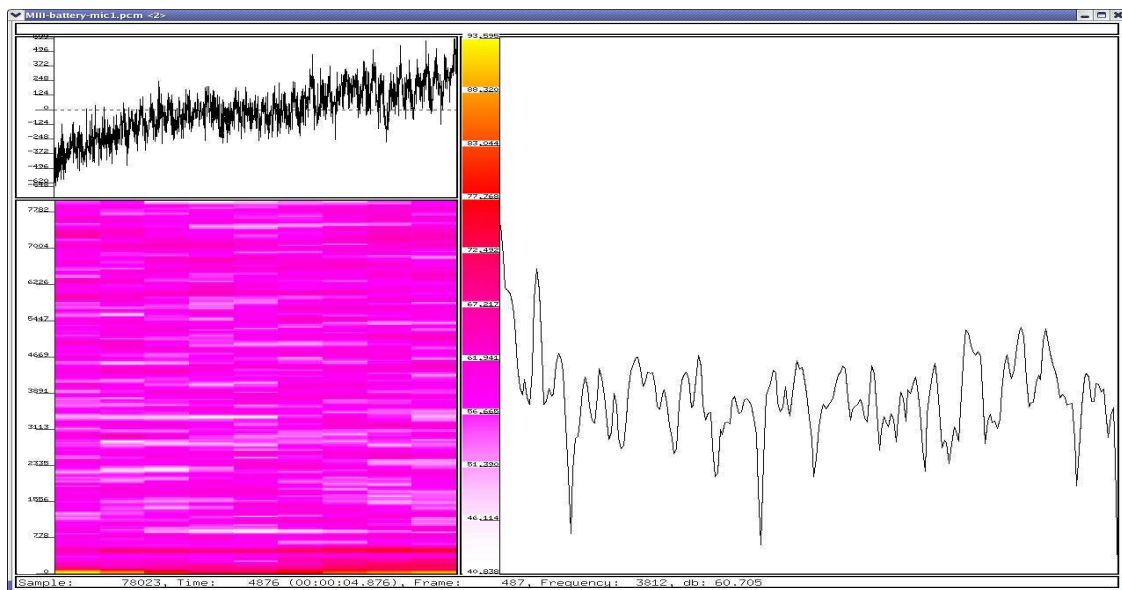
Figure 5: Silence sequence; here, the device noise is more evident both in its dynamics and in its spectral characteristics.

From Figure 5, one can observe that the noise dynamics (between -300 and +300) involves about 9 bits. It was clear that losing 9 bits out of the first 16 most significant ones was a heavy limitation to the potential of this array.

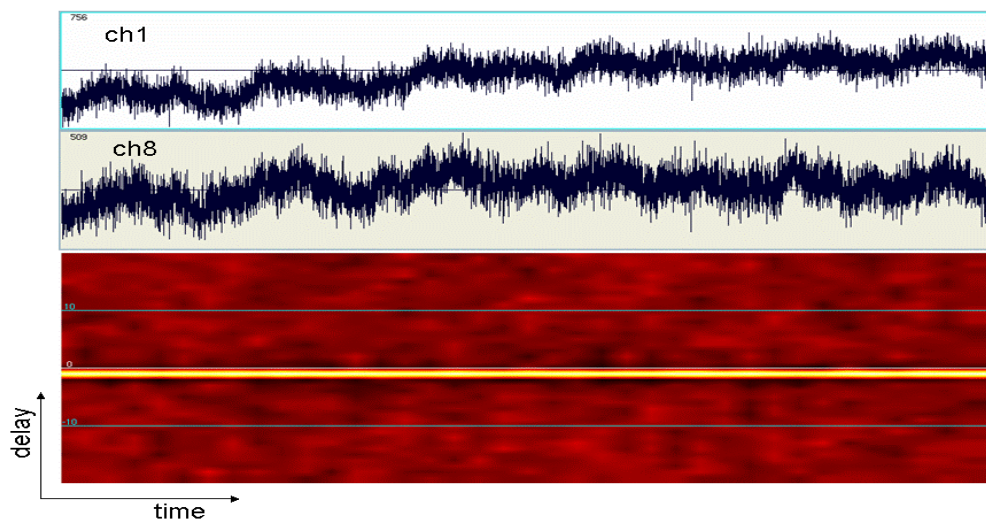
Figure 8: Signals extracted from Channel 1 and Channel 8. The peak of the CSP function reported in the lower part of the figure shows a strong coherence between the device noise sequences.

microphones. It dominates over acoustic background noise of a relatively quiet environment. This noise has a “common mode” within the 8 channels of each array micro-board. Different modules (e.g ch1-8 and ch9-16) have different and uncorrelated noise components. This is evident again on the basis of a CSP analysis. Figure 8 shows the noise coherence between ch1 and ch8: in this case, a strong coherence is evident between the (mainly electrical) noise sequences.

So, only a maximum of 8 microphones (one per micro-board) in an array of 64 microphones are entirely uncorrelated, thus reducing dramatically the usefulness of 64 microphones and related bandwidth.

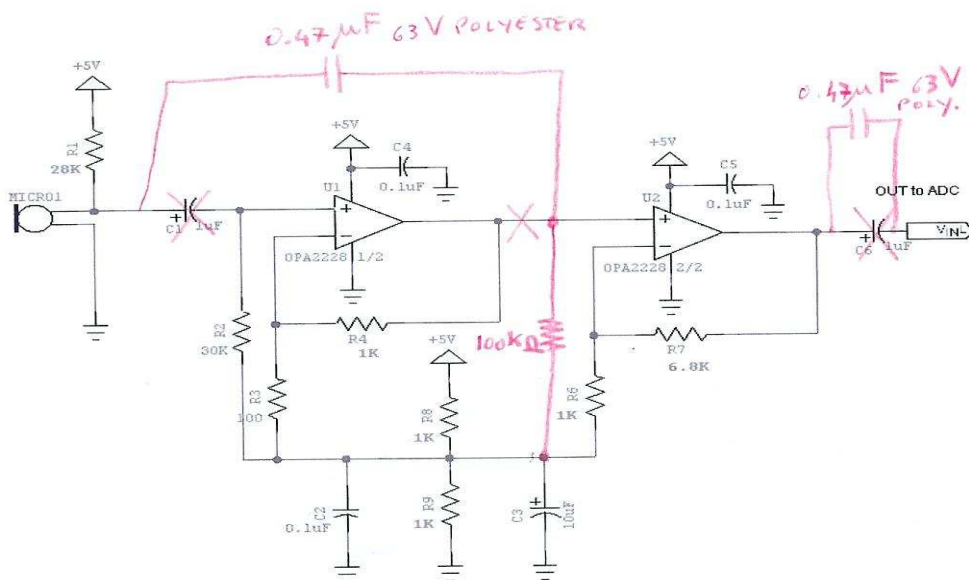
Figure 13: This figure shows the modification on the amplification stage relative to one microphone.

We substituted the two capacitors, placed at the very beginning and at the very end of the amplification stage, with two polyester 0.47  $\mu\text{F}$  capacitors, which generate much less noise. We then chose to limit the amplifier gain: we thought the first stage gain was 100 and the second one was 6.8 (as reported in [1]), so we bypassed the first stage via a 0.47 $\mu\text{F}$  capacitor, keeping the second stage polarization to the phantom GND with a 100KOhm resistor.

We then realized the first stage gain is actually 10. The original gain of 68 was reduced to 6.8, as depicted in Figure 13, but one could also keep the first stage rather than the second one

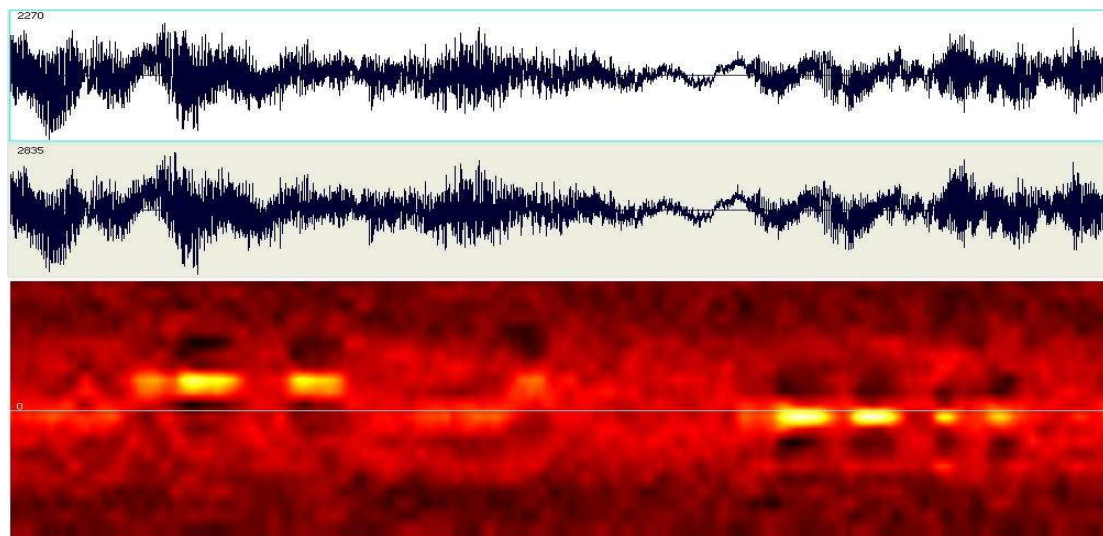
Figure 15: Signals extracted from Channel 1 and Channel 8. The peak of the CSP function reported in the lower part of the figure shows a strong coherence only when either one speaker (in the left side) or another speaker (in the right side) are talking.

We substituted the 5V regulator with a non-rechargeable battery: we put 3x4.5V Zn-C batteries in parallel to feed 3 microboards. The artificial correlation effect, which was visible via CSP [3], disappears (see Figure 15). To make this improvement practical, we then switched to a combination of 4x1.2V Ni-Cd batteries in series: they give the best performances. We later realized that feeding more than one microboard with the same group of batteries, or equivalently with the original 9V transformer, creates the 8 and 16 kHz disturbance (see Section 3.5).

We concluded that the best solution was to feed the analogue part of each microboard with 4 x1.2V, 5Ah batteries, so to guarantee the galvanic de-coupling of each power supply source.

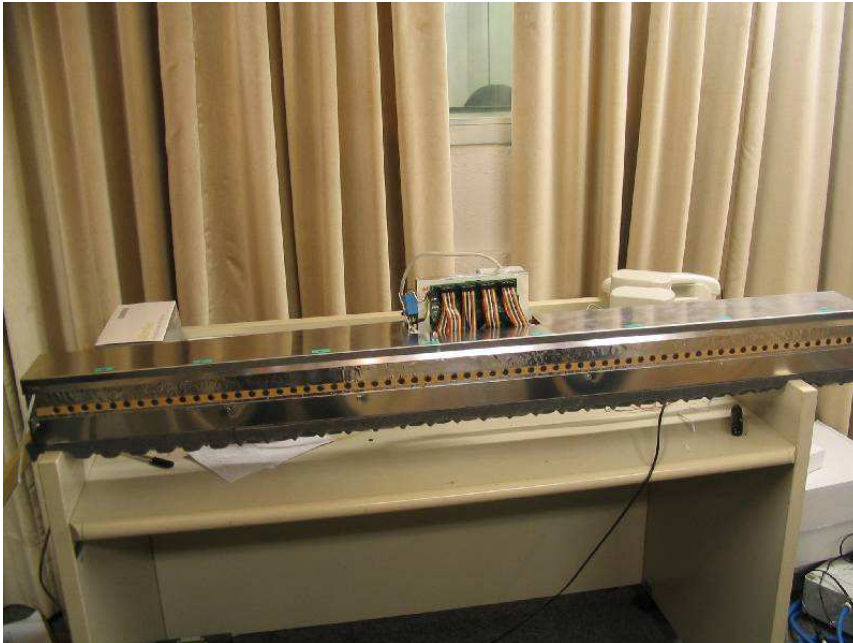
**Figure B-4: the IRST-MarkIII after the intervention: an additional Faraday cage was added to isolate the last 50Hz noise residual.**

Furthermore, even with the best power supply available, still a light 50Hz disturbance persists: it is much lower than the one coming from the power supply and it is totally due to environmental electromagnetic fields. By consequence it can be definitely eliminated by surrounding the MarkIII with a Faraday cage.

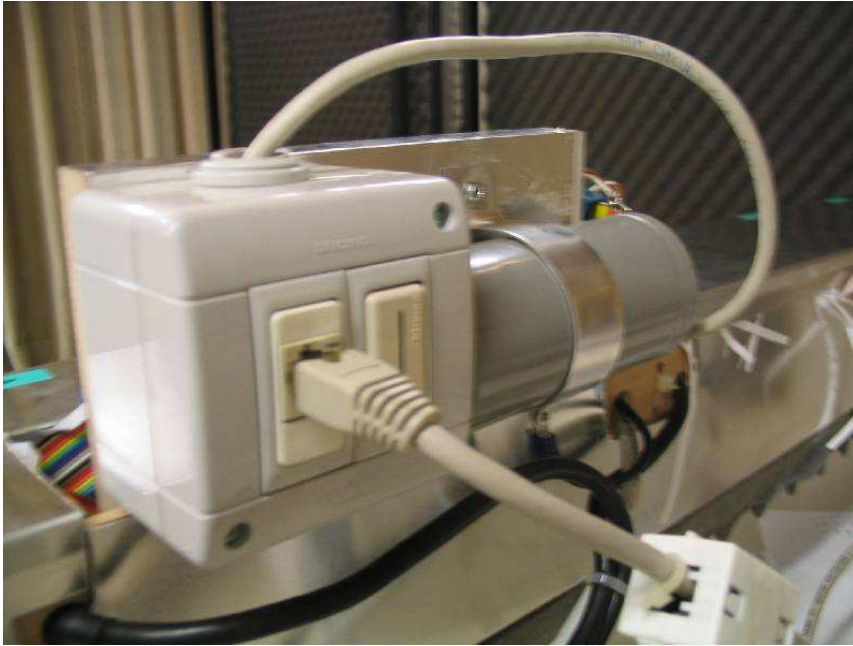
**Figure B-7:** The motherboard from behind: an Ethernet socket has been added for practical purposes only. The big 15 mF condenser is also visible.

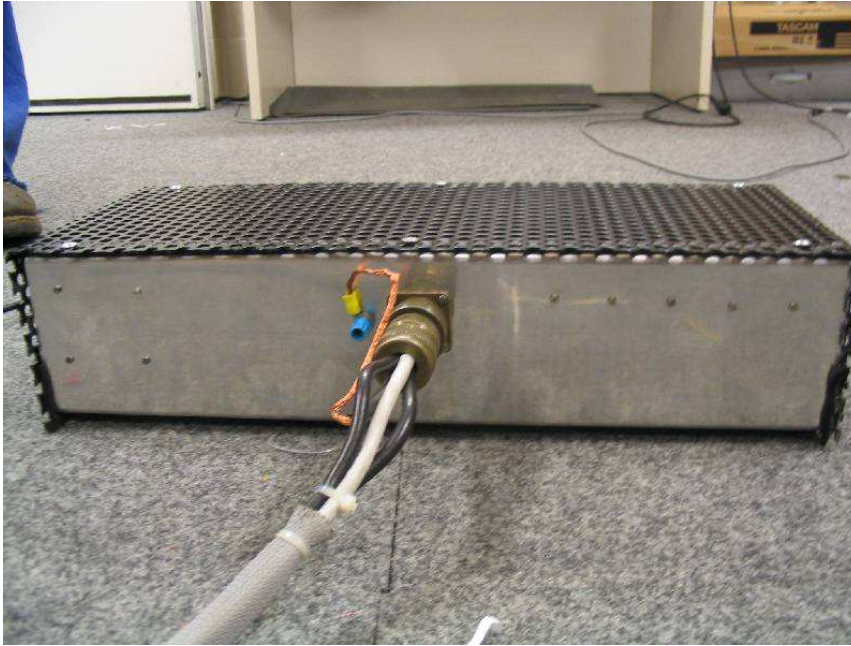
**Figure B-9: Back of the power supply box: the ground is connected separately. The box is surrounded by a metal cage.**

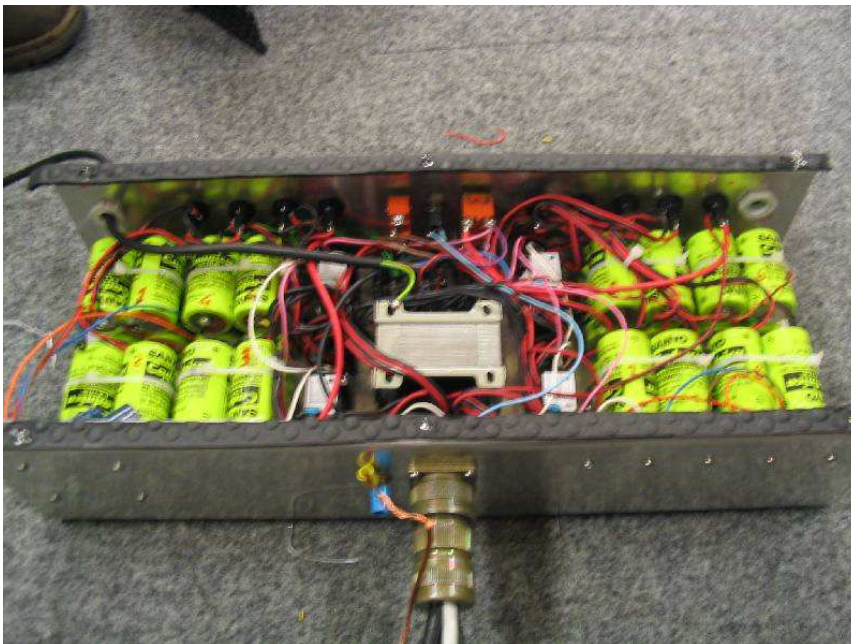
**Figure B-10: Inside of the power supply box: from the 8 groups of 4 batteries the power supply passes through the red and violet cables, placed on purpose in those positions. The transformer which provides power supply for the digital part (in acquisition state) and recharges the batteries (in recharging state) appear in the center of the box.**

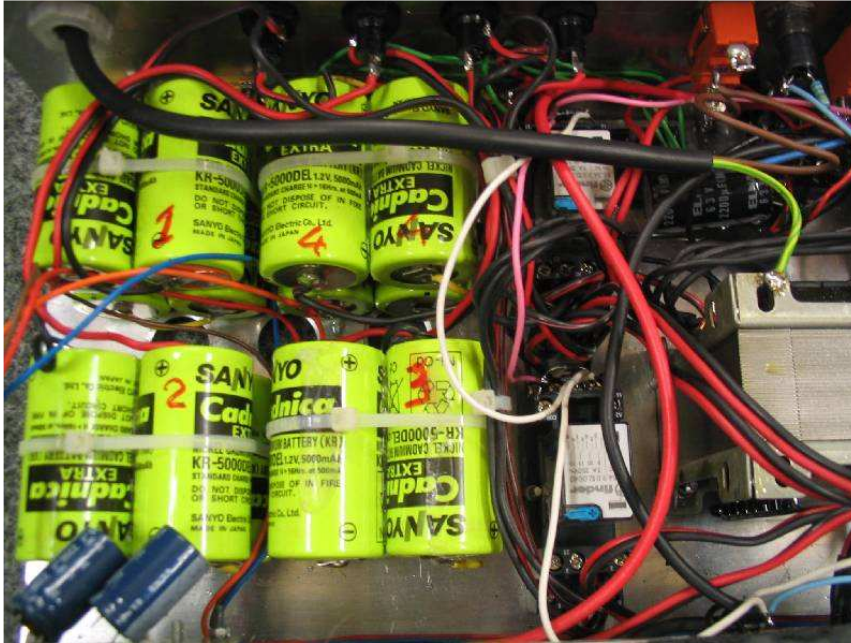
**Figure B-11: Particular of the power supply box: battery groups 1 to 4 are shown together with tension regulators and 2 relays.**
